Design And Construction Defects In The Buildings Of Balakot (Pakistan) And Surrounding Areas In Relation To Earthquake Loading

Muhammad Azhar Saleem
*Lecturer, Department of Civil Engineering
University of Engineering and Technology
Lahore, Pakistan*

Abstract

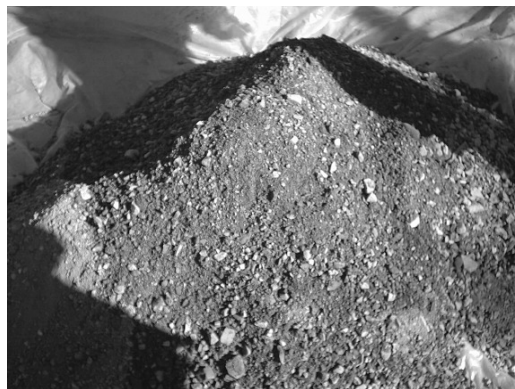
The concrete used in the suburb of Balakot was composed of poor aggregate material having significantly low cement-to-aggregate ratio. According to a mason, a mixture of fine and coarse aggregate is taken from some river-bed in Ghari Habibullah (Fig: 1). Three wheelbarrows of this mixture and one cement bag are mixed to prepare concrete.

Figure 1: Mixture Of Fine And Coarse Aggregate Used For Preparing Concrete

The local people believe that this gives a cement-to-aggregate ratio of 1:3 in the concrete. Actually one wheel barrow can have 4 cement bags so the cement-to-aggregate ratio becomes 1:12, the resulting concrete does not fall in the category of structural concrete. Fine and coarse aggregates were also not having any fixed proportion and a large variation is expected in concrete strength even within same structure or a structural member.

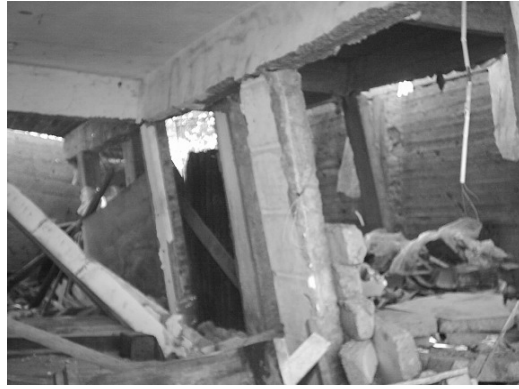
According to ACI-318 (§ 21.4.1.1), for a frame member subjected to bending and axial load, the shortest cross sectional dimension measured on the straight line passing through the geometric centroid shall not be less than 12". Furthermore ACI 21.4.1.2 states that the ratio of the shortest cross sectional dimension to the perpendicular dimension should not be less than 0.4. The column sizes observed in Balakot and other areas were 4.5" x 9", 4.5" x 12" and 4.5" x 15". These slender columns sufficiently reduced the strength of lateral force resisting system. When the earthquake struck, concrete frames exhibited large sways resulting in collapse of infill masonry and breaking of beam-column joint (Fig. 2). One important observation is that very few columns were found failing due to buckling; it indicates that columns had reasonable strength for gravity loads but not for lateral loads.

Figure 2: Concrete Frame Exhibiting Large Sway

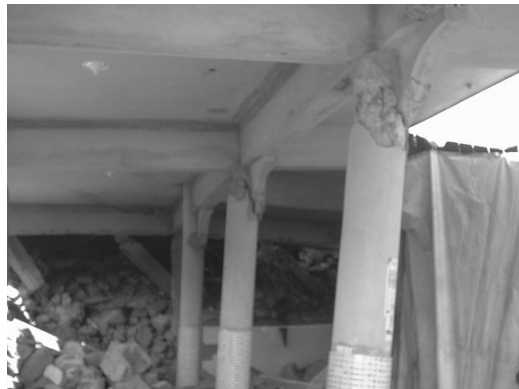
Due to inadequate shear reinforcement and improper development lengths at the joints, most of the failures initiated by joint rupture (Fig: 3 & 4). For a special moment resisting frame, spacing of transverse reinforcement, within two times the depth of member from face of joint, must not be less than one quarter of minimum member dimension (ACI-318, § 21.4.4.2). This means that, for a column having least lateral dimension 4.5", the shear reinforcement should be # 3 @ 1" c/c. Even for intermediate moment resisting frame the limit for spacing is one-half of the minimum member dimension which means # 3 @ 2.25" c/c. The provided shear stirrups were either # 3 @ 9" c/c or # 3 @ 12 c/c.

Figure 3: Joint Failures Of Balakot Jamia Mosque

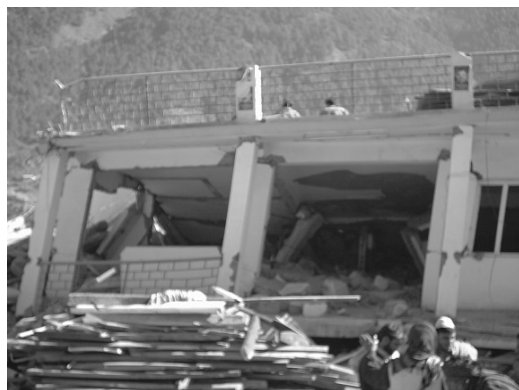
Figure 4: Large Sway In Frames

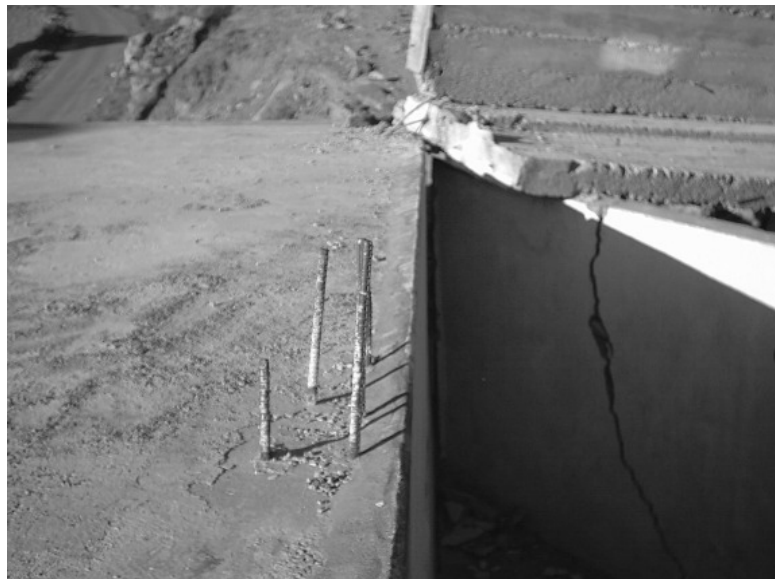
Lap lengths observed in various structures in Balakot were ranging from 5” to 12”. A mosque in Pumbara village, about 8 km from Balakot city, lost its four minarets projecting from top story columns, which fell down due to insufficient lap length (Fig: 5). Lesser lap reduces strength proportionately. For instance if 5” lap is provided for # 4 (grade 60) steel bar, which requires 28.47” lap, the strength which can be developed is:

$$\frac{5''}{28.47''} \times 60000 = 10537 \text{psi} = 0.176 f_y$$

Figure 5: Insufficient Dowels Lengths Left For Extension Of Mosque In Pambara Village

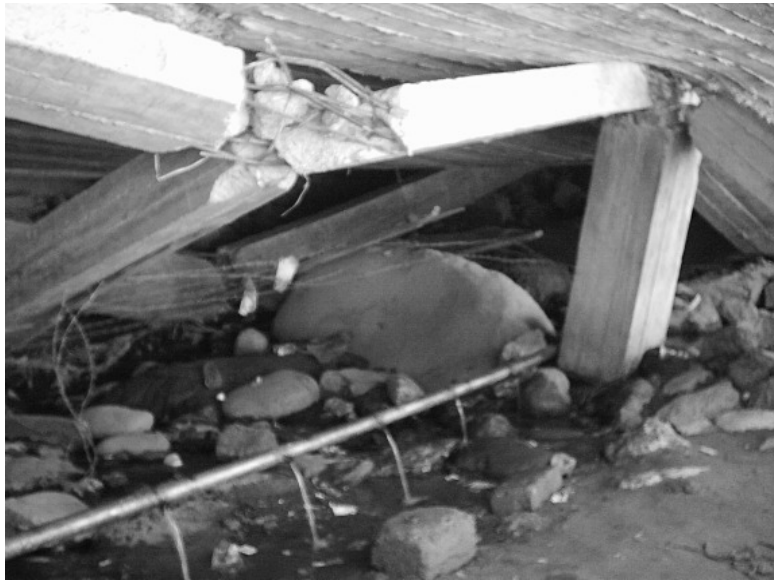
It was frequently noticed that concrete frames and slabs were not cast monolithically (Fig: 6 & 7). Frames were constructed and slabs were placed above them resulting in weak connection between frame and slab. T-beam behavior could not be developed, reducing the effective cross sectional properties including moment of inertia and area. When the earthquake struck, the frames got separated from slabs and started swaying independently. This relative movement between frame and slab shattered overall stability of structures.

Figure 6: Frame Non-Monolith With Slab

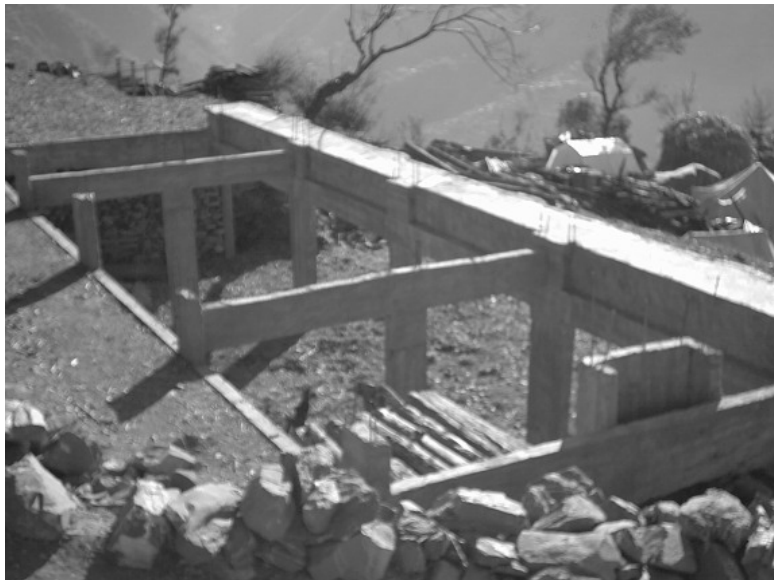
Figure 7: A Frame Structure In Pambara, Ready For Placing Slab.

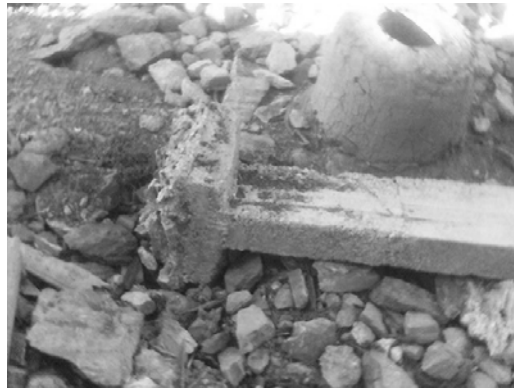
The columns of a frame structure along the mountain slope of village Pambara (Fig. 8 & 9) were uprooted from foundation. Two things were clear from this type of failure:

- The depth of footing was much less, 1' to 1.5', which proved to be insufficient to provide resistance against over-turning.
- The footing was drastically under-sized. In some cases, a properly formed square or rectangular footing was not provided; instead only a lumped mass of concrete was used. The moment of inertia of footing was so less that it could not provide fixity to column and was not able to resist rotation, resulting in uprooting of column along with the foundation.

Figure 8: Inadequate footing of a slender column

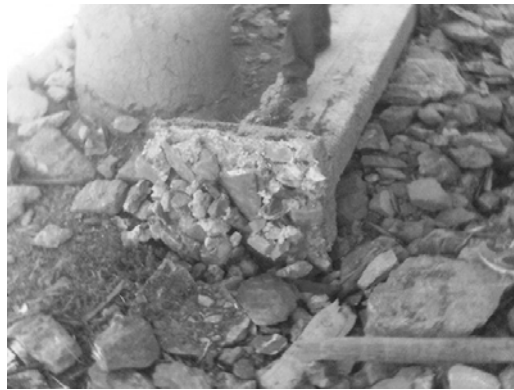
Figure 9: Inadequate column footing

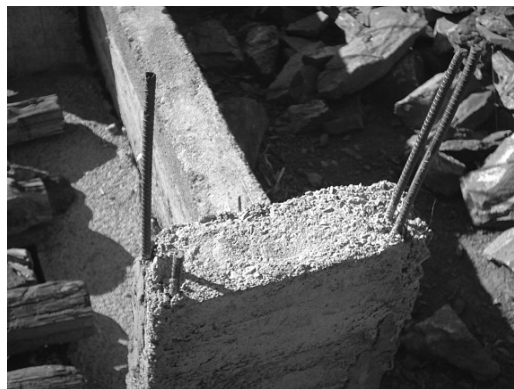
ACI-318, §7.5.1 states that reinforcement shall be accurately placed and adequately supported before concrete is placed and shall be secured against displacement. The structures observed in Balakot and surrounding area had improperly placed steel bars with uneven spacing and non-uniform clear cover (Fig: 10 & 11).

Figure 10: Steel Bars In Column With Uneven Cover And Improper Placement

The bars, which were placed improperly, became ineffective and did not contribute in providing strength. So, poor construction material and improper placement of reinforcement resulted in overall low construction quality.

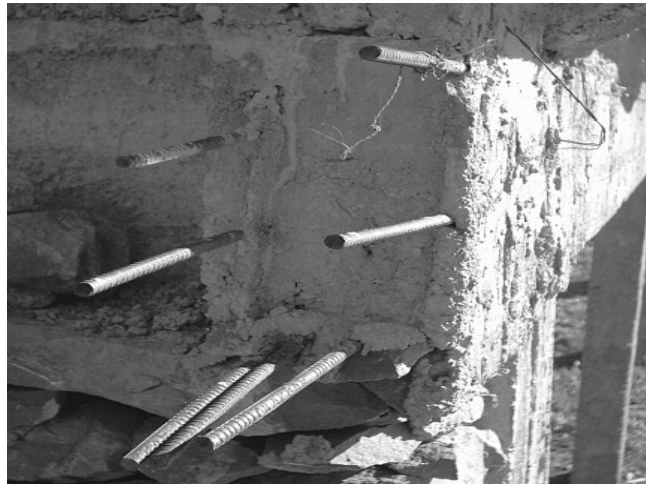
Figure 11: Improperly Placed Steels Bars In A Beam

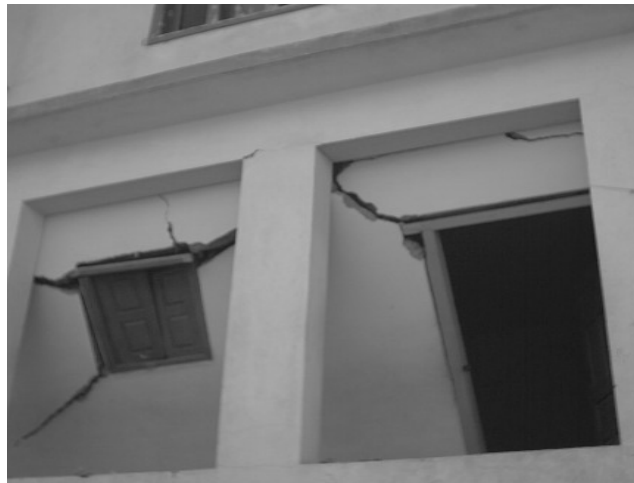
The main mosque in Pambara had un-reinforced concrete walls. During the earthquake, few wall panels overturned as a whole and some of them suffered long shear cracks and broke into pieces (Fig: 12).

Figure 12: Un-Reinforced Concrete Wall Panels Collapsed Due To Earthquake

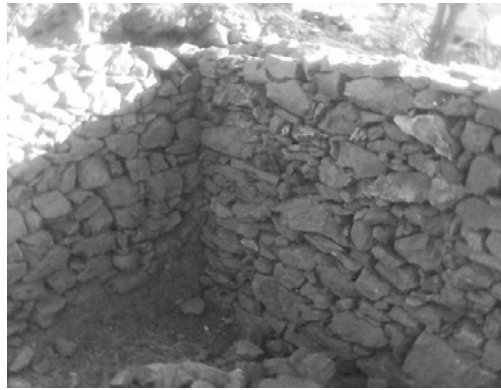
Rubble masonry using undressed stones without bond is highly unsafe especially under lateral loading. Un-bonded rubble masonry is frequently used in outskirts of Balakot (Fig: 13). When this rubble masonry was subjected to earthquake it spread like loose soil and failed to provide required shear strength.

Even if bonded masonry had been used, it would also have not been appropriate because the stones used were uneven and arranging them in the form of wall could not ensure that they will behave as one unit like in a brick masonry wall.

Figure 13: Un-Bonded Rubbles Being Dressed To Make A Load Bearing Wall Structure.
