Sustainable Technology of Conservation of Wall Copings of Architectural Heritage Torso

Oto Makýš

*Architectural Heritage Technology Centre, Civil Engineering Faculty of the Slovak University of
Technology in Bratislava, Slovakia
oto.makys@stuba.sk*

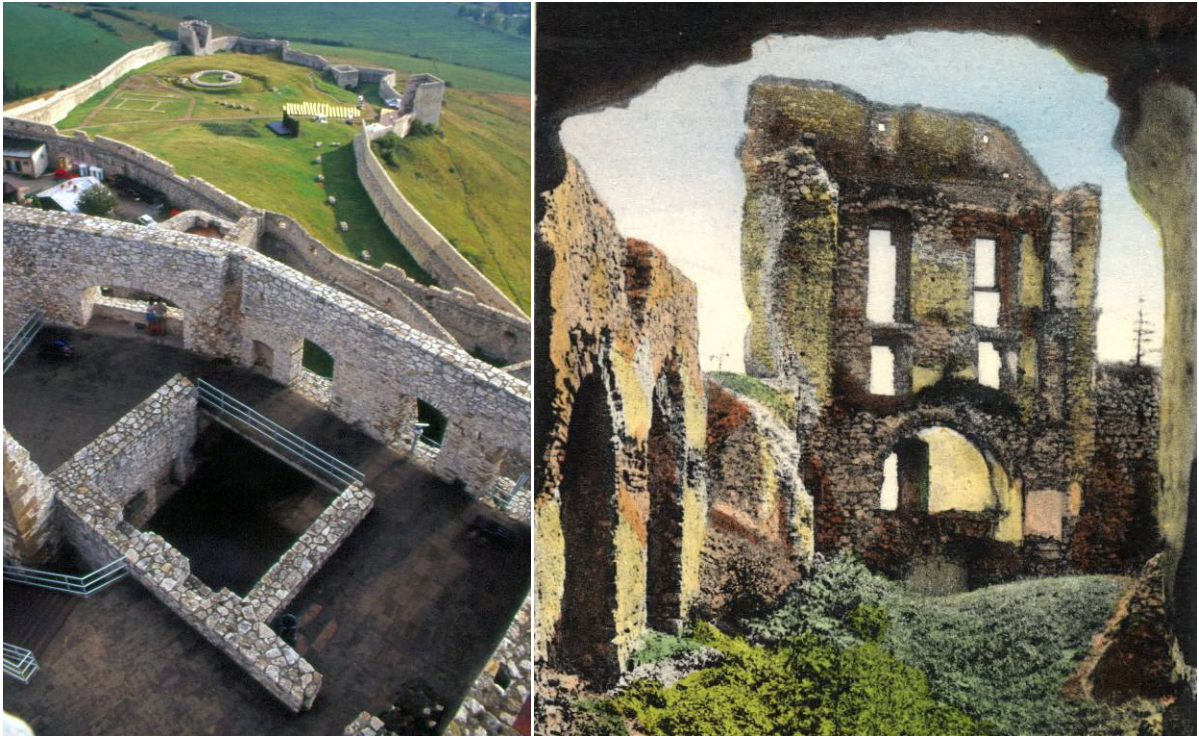
Figures 1, 2: Typical examples of wall copings of ruined architecture - left the castle of Spiš with not naturally looking straight line of copings (after the conservation) and the castle of Pajštún with natural curved copings of a “romantic appearance” (postcard, 19th century) – both in Slovakia.

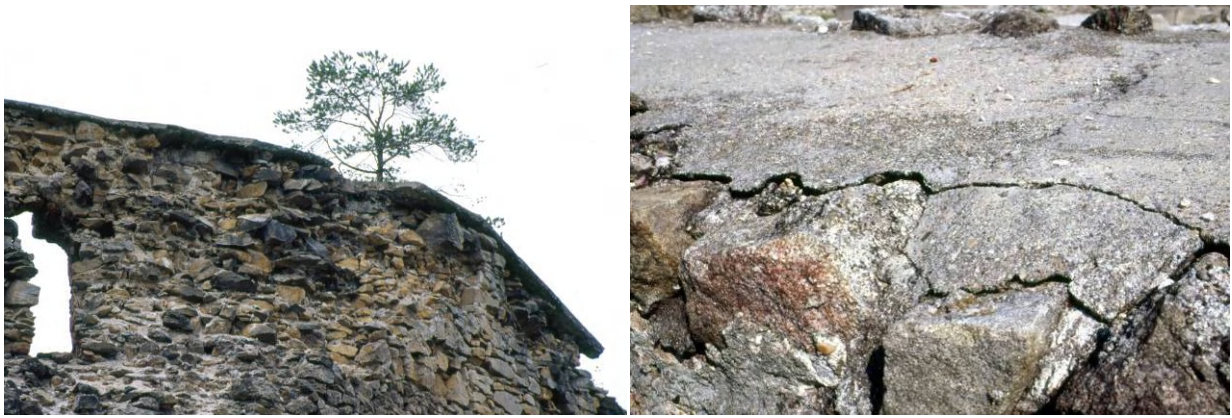
Figures 3, 4: An interesting example of conservation of the castle of Liptovský Hrádok (Slovakia) sometimes during the 30-ties (left). A layer of concrete was simply placed over the wall copings, which did not protected the wall below against the rainwater very effectively, but it has anyway saved the shape of the ruin for the following 80 years. Right a newly placed concrete (80-ties) over o top of a roman castle ruin in Gerulata (Bratislava, Slovakia) – cracks in concrete are already visible, which allow rainwater to penetrate the original masonry and the concrete cover is already separated from the original by a huge sheet breakaway.

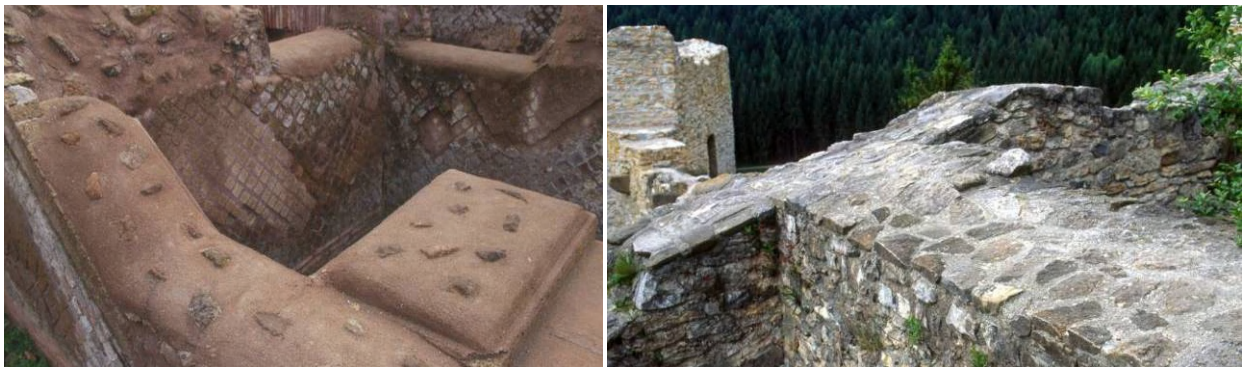
Figures 5, 6: Left - an example of the use of mortar filled with some pieces of brocks on the wall coping of roman walls at Ostia (Italy) – the whole shape of the coping looks generally a little bit strange. Right straightly shaped wall coping of the castle of Likava (Slovakia), with the use of flat stones placed into concrete – not natural deformation of the shape of the walls is mostly visible only from a near look.

A layer from mortar or concrete is usually very easy to realize and does not acquire specific skills from the workers. The most important advantage of it is its ability to copy a curved - originally preserved -

shape of the wall. It was (even in Central European climate) quite successful, especially because its technical life is relatively long – specifically if the material is least absorptive, or it is placed on well ventilated constructions, which helps them to dry out quickly after rains. On the other hand, if the wall below the mortar or concrete cover is still watered it is then usually largely damaged by high erosion, even without any concern to a high technical life of its cover.

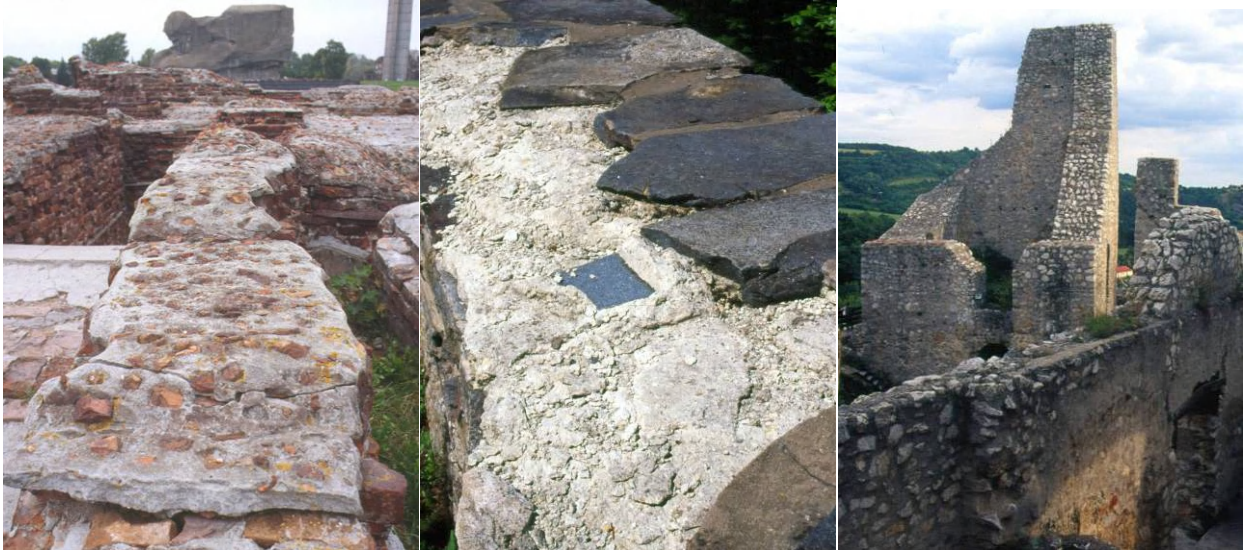
Figures 7, 8, 9: Examples of various technologies – use of lime mortar filled with pieces of bricks on the fortress of Brest (Belarus) does not protect the walls very much, as it mostly broke away already (left). Use of volcanic stone plates, placed into strong cement mortar did also not worked properly – castle of Vígľaš (Slovakia), 8 years after realization (center) and very artificially formed skyline of the ruin of Beckov by massive use of added stone masonry fitted by deep injection with expansive cement (right).

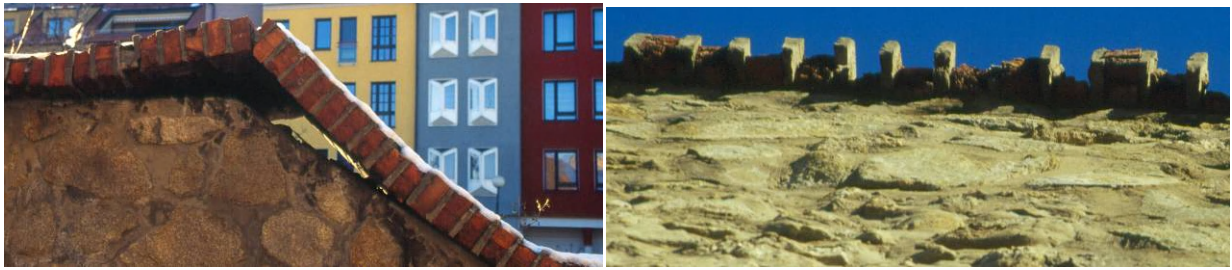
Figures 10, 11: Use of materials with very different physical characteristics in comparing to the original ones (both are examples of the city walls in Bratislava, Slovakia) – on the left the dilatibility of the wall coping made from brick on cement mortar is much different to that one of the stone masonry, on the right the use of materials with very different erosion resistance (very hard cement mortars combined with weak bricks) has lead to continuous degradation of the brick part of the coping, where only the cement mortar in joints could resist the erosion – very funny appearance of the wall coping was reached (unplanned).

The sense of this technology was to flatten the wall coping into straight (mostly horizontal) lines by adding additional layer (or more layers) of stone masonry to the original. The most important disadvantage lies in a principally changed skyline of the ruin, which is usually artificial (without any reference to the original look of the walls). On the other hand – in many cases this is one of the ways how to deal with needs of practical use of a torso in present times, where the straight lines are needed i.e. for creating (fulfilling) a closed barrier from original walls around the whole castle area, creating a kind of railing alongside of the walkways, or creating a barrier on lookout points, etc. From the technology point of view it works like the previously described technologies.

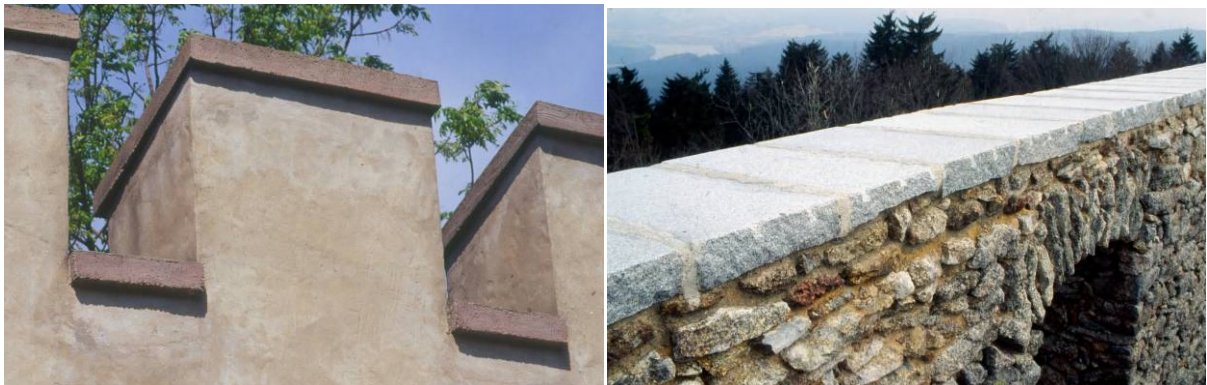
Figures 12, 13: Covers made from concrete (left – on the castle of Vígľaš in Slovakia) and from stone plates (right the castle of Vítkův hrádek in Czechia) – both are giving the ruin a slightly artificial appearance and also their protection role is a bit far from being perfect.

Protecting plates are usually made from stones, ceramics, concrete etc. The most important criteria are to ensure the water non-absorptivity of the cover. Otherwise if the water ingress through the cover, the masonry below it slowly, but continuously corrodes. More appropriate is therefore to use rather lime then cement mortar for fixing the plates, as the cement mortar is of higher strength, but it is also of lower flexibility and porosity and therefore it is less erosion resistant. A precise realizing of the joints is also of high importance, especially their hydrophobization. A technical, life of such a technology can (in Central European condition) reach to approximately 30 years and more. An important disadvantage is the changed shape of the ruin, there stones, or plates of irregular shapes are better to use (i.e. from cleft stones).

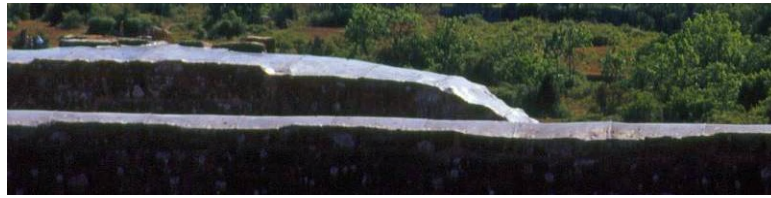
Figure 14: An example of use of tin plates for protection of walls (Borgholm castle, Öland, Sweden)

A good way of protection of wall copings is the use of tinplates – especially from led tin, which can usually be anchored to the walls just by its forming around the stones. From this point of view it is a very soft technology towards conservation of original material of the walls, but then it can also be very easily dismantled. Therefore it can be used only in areas where is no risk of theft.

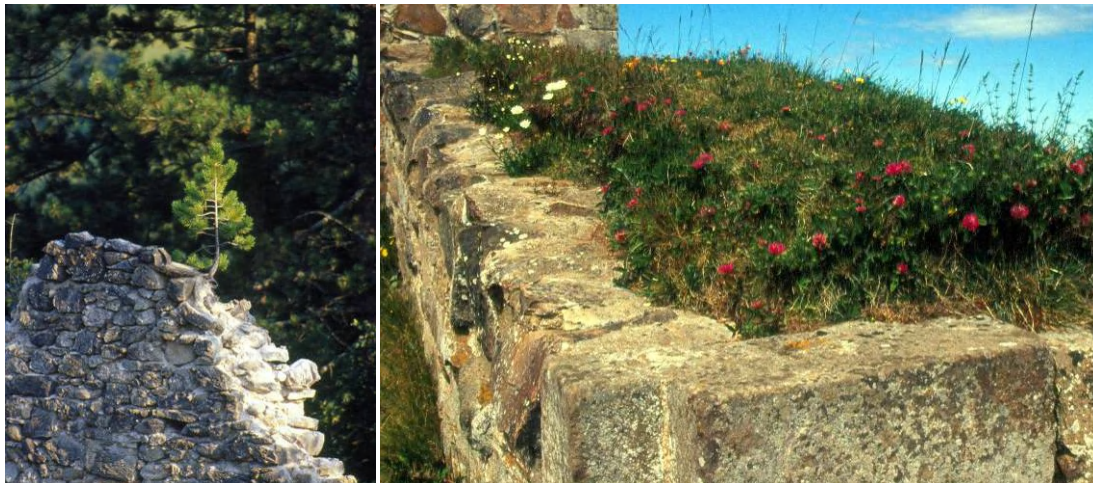
Figures 15, 16: Unwanted vegetation – a small tree on the walls of the Sklabiňa Castle in Slovakia, which should be immediately removed, and a nicely planted grass and flowers cover on the top of a wall of the Brahehus ruin in Sweden – even such a type of the cover has some limits of its technical life, given by relative low erosion resistance of the sides of the “flower-pot”.

Removal of natural regenerated vegetation from the constructions and areas of architectural torso is generally considered as right and useful. But removal of grasses, flowers, etc. from the top of wall copings does not have - more-less any - practical use. Vegetation growing on the top of the walls usually likes basic nature (alkaline) environment, which is also created by the rests of original lime mortar, used at constructing the walls in the past. At the use of cement - after some time (years) – the surface of the masonry is covered by moss, which indicated a change of the environment of the construction from alkaline to acid. This indicated an acceleration of a general decay of the material of the construction. Vegetative cover is usually (but not always!) developed by itself on the wall copings in a natural way. It is very important to remove any of trees, or bushes from it, as they destruct the masonry in a deep way by their roots. Another advantage of the vegetative cover (carpet) is that it strengthens a romantic appearance of an architectural torso in the countryside. During conservation works it the usually (of course not always) most easy to protect the existed, naturally developed cover on the wall copings, but if it has to be removed, it can also be reconstructed. One of the ways is to use some pieces of vegetation carpet, acquired from similar position in the surrounding countryside (Makýš, O., 2004). But before placing it on the top of the walls, it is usually important to strengthen the top of the masonry (i.e. using some of the appropriate methods as described above – but mainly based on lime mortars use).

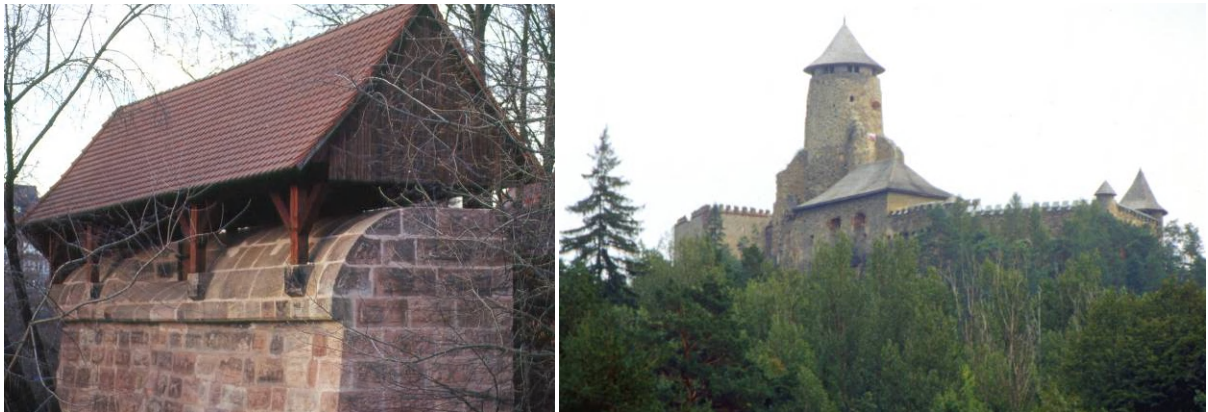
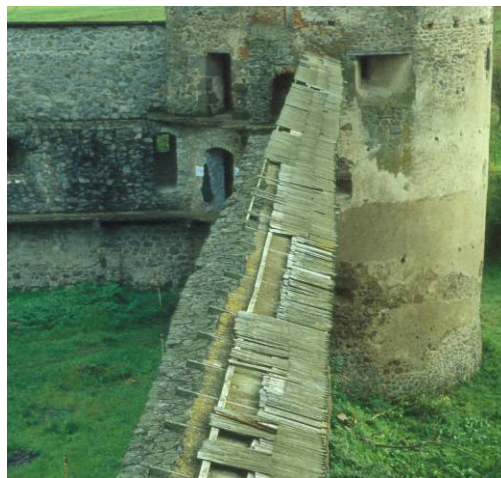
Figures 17, 18, 19: Three examples of newly built roof on fortifications – a reconstructed roof of a bastion of the town wall of Nürnberg (Germany, left), a very good example of a newly built roof on the tower of the castle of Stará Ľubovňa (Slovakia, right) and a largely damaged roof cover of the walls on a not maintained ruin of the fortified monastery of Bzovík (Slovakia, down).

The most traditional way how to protect walls was to cover them with roofs of various scales and shapes. It could be also nowadays the best possible way to preserve walls, but it is - alas - either from technological, or even more from methodic point of view only of a limited use. Roofs can easily be used on longer sections of straight lines of relatively little damaged walls, but it is nearby to impossible to use them on damaged walls with teeth like skyline. Another problem is that a roof must be maintained (and even watched), which means that it can be used in locations of permanent use - with persons, who care about them.
